**Flood Control Project Maintenance  
Levee Inspections**

**Maintenance Issue Types Only, Levee Inspection Report By Mile - Fall 2018**

**Reclamation District No. 1660 Tisdale**

Waterway	Bank	Unit Miles	Inspection Start/End	Inspector
Unit No. 01 Sacramento River	Left	2.94	11/01/2018 11/01/2018	Bob Duffey

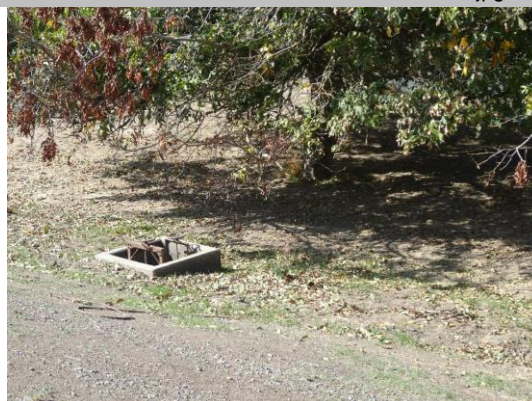
Photo 1 of 3 : UCIP\_FA\_2018\_46670\_38107.jpg

Comment Code						
Inspector Comment						
FS_ID:46670						
DS_ID:22489						
EP_NO: N/A						
Repair Type: Non-Urgent						
Crossing Status: Found						
UCIP Comments: - needs proper abandonment.- opening of landside pipe almost burried.						
FIELD_STRUCT_DESC: *ABANDONED* 24-inch corrugated metal gravity drainage pipe through the levee, 16.4 feet below the crown. Two corrugated metal cutoff walls. Slide gate in a concrete well at the waterside (WS) toe. (IV A-Winship). USACE bench mark on the top of the headwall at the landside (LS) toe. [Additional Reference(s): DWR Levee Log, 2005. USACE Sacramento O&M Manual 133, August 1955, (Station 2+07.8)].						
FS Date: 10/10/2013

WS view: concrete box on levee slope. No pipe found on berm and river bank.

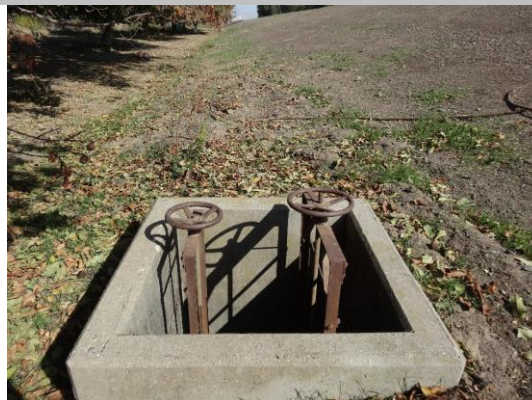
Photo 2 of 3 : UCIP\_FA\_2018\_46670\_38106.jpg

WS view: two slide gates in concrete box on levee slope.

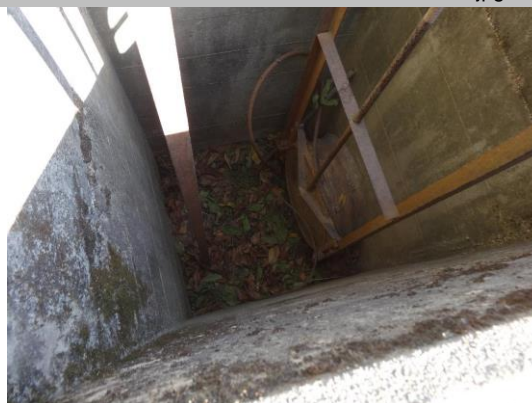
Photo 3 of 3 : UCIP\_FA\_2018\_46670\_38105.jpg

WS view: closer view of two slide gates in concrete box on levee slope.

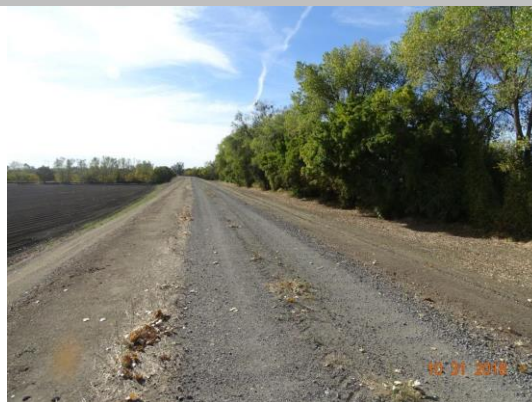
Photo 1 of 1 : FA\_2018\_RD1660\_8\_19\_20181102\_00018.jpg

LM Start	0.82	Rating **	A	Issue No.	19
LM End	0.82	Issue Type +	Ma	Location *	LS
Category	Earthen Levee			GPS Latitude/Longitude	
				Start	End
Item	Vegetation			39.051565 °	39.051565 °
				-121.839770 °	-121.839770 °
DWR ID	DWR_RD1660_01_f_2018_19				
Comment Code					
V1 : Control annual grass and weeds on the levee slopes and easements.					
Inspector Comment					
There was no vegetation on both slopes.

View of no vegetation on both slopes.

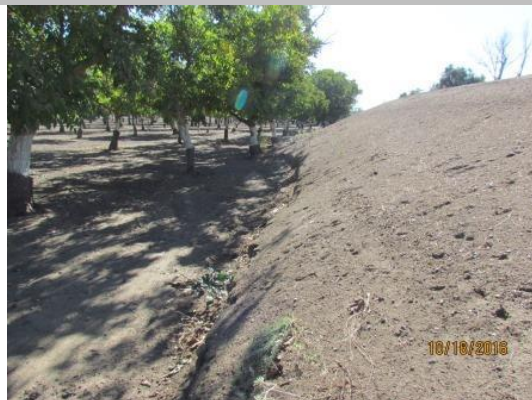
Photo 1 of 1 : FA\_2018\_RD1660\_8\_2\_20180905\_00002.jpg

LM Start	2.37	Rating **	M	Issue No.	2
LM End	2.37	Issue Type +	Ma	Location *	LS
Category	Earthen Levee			GPS Latitude/Longitude	
				Start	End
Item	Slope Stability			39.034107 °	39.034107 °
				-121.825152 °	-121.825152 °
DWR ID	DWR_RD1660_01_s_2012_2				
Comment Code					
S1 : Repair slope instability.					
Inspector Comment

View of the toe cut by the farmer on the landside.

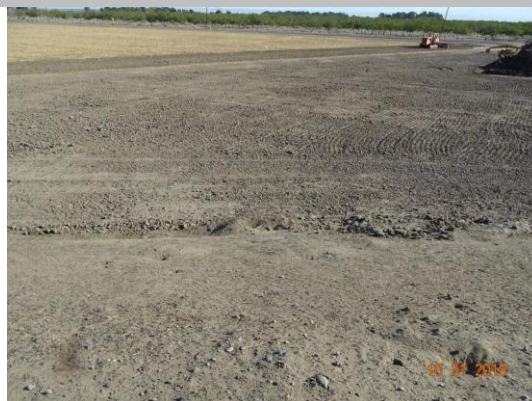
Photo 1 of 1 : FA\_2018\_RD1660\_8\_21\_20181102\_00019.jpg

LM Start	2.38	Rating **	U	Issue No.	21
LM End	2.38	Issue Type +	Ma	Location *	LS
Category	Earthen Levee			GPS Latitude/Longitude	
				Start	End
Item	Animal Control			39.034032 °	39.034032 °
				-121.825120 °	-121.825120 °
DWR ID	DWR_RD1660_01_f_2018_21				
Comment Code					
A3 : No rodents visible, but rodent burrows visible; need to backfill and compact or grout burrows.					
Inspector Comment					
Repair the rodent holes along the landside slope.

View of rodent holes along the landside slope.

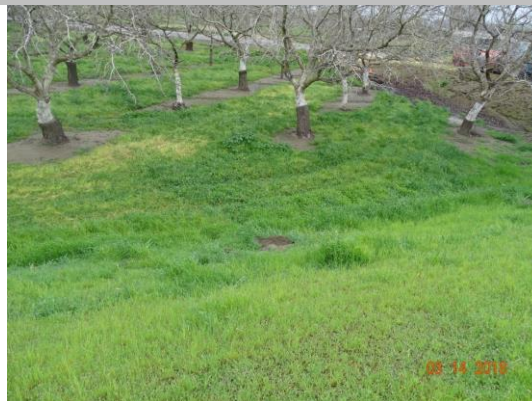
Photo 1 of 1 : FA\_2018\_RD1660\_8\_20\_20180905\_00008.jpg

LM Start	2.57	Rating **	M	Issue No.	20
LM End	2.57	Issue Type +	Ma	Location *	LS
Category	Earthen Levee			GPS Latitude/Longitude	
				Start	End
Item	Animal Control			39.031625 °	39.031625 °
				-121.823492 °	-121.823492 °
DWR ID	DWR_RD1660_01_s_2018_20				
Comment Code					
A3 : No rodents visible, but rodent burrows visible; need to backfill and compact or grout burrows.					
Inspector Comment					
Repair the rodent holes along the landside slope.

View of the rodent holes along the landside slope.

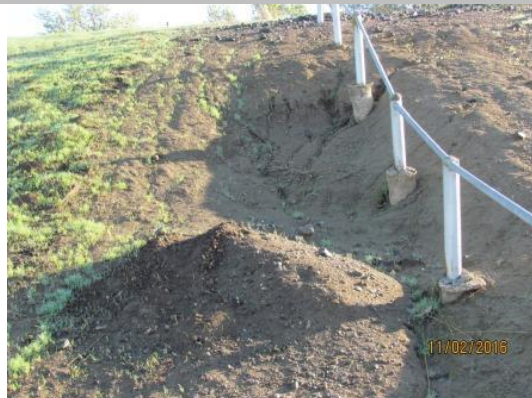
Photo 1 of 2 : FA\_2018\_RD1660\_9\_6\_20180905\_00001.jpg

LM Start	0.00	Rating **	M	Issue No.	6
LM End	0.00	Issue Type +	Ma	Location *	LS
Category	Earthen Levee			GPS Latitude/Longitude	
				Start	End
Item	Slope Stability			39.032910 °	39.032910 °
				-121.743665 °	-121.743665 °
DWR ID	DWR_RD1660_02_f_2016_6				
Comment Code					
S1 : Repair slope instability.					
Inspector Comment

View of the slope instability looking from the landside toe.

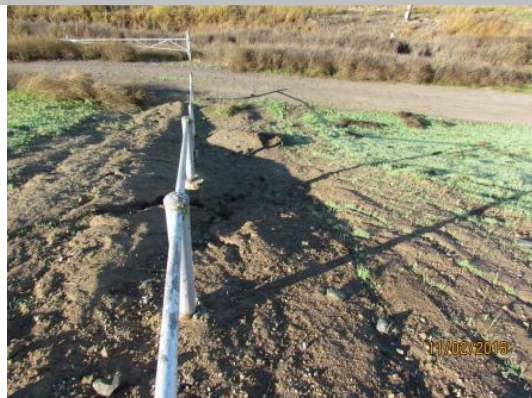
Photo 2 of 2 : FA\_2018\_RD1660\_9\_6\_20180905\_00002.jpg

Another view of the slope instability looking from the levee crown.

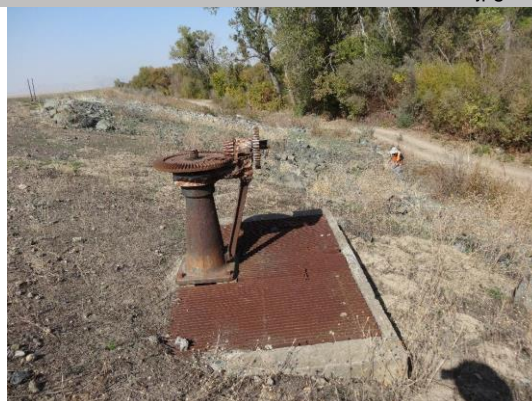
Photo 1 of 3 : UCIP\_FA\_2018\_22663\_38248.jpg

Comment Code					
Inspector Comment					
FS_ID:22663 DS_ID:22495 EP_NO: 10020 Repair Type: No Action Needed Crossing Status: Found UCIP Comments: - pipe/opening not visible as it was submerged into water on both sides.- it seems that 36-inch concrete pipe through the levee. It needs confirmation from LMA/DWR Inspector.- USED bench mark on landside concrete vault. FIELD_STRUCT_DESC: [Reclamation District No. 1660 (RD1660) Drainage Pump] 48-inch by 84-inch reinforced concrete outfall structure through the levee, 34 feet below the crown. Slide gate in a 4-foot by 8-foot concrete riser on the waterside (WS) slope. (Retention of a 4-foot by 7-foot concrete culvert outfall drain through the levee, 34 feet below the crown, and a slide gate in a concrete well authorized under Automatic Board Order (ABO) issued as Permit No. 10020, 1974 - Leo Bandoni, care of John Digardi). [Additional Reference(s): DWR Levee Log, 2005. USACE Sacramento O&M Manual 133, August 1955, (Station 1044+60), two 4-foot by 7-foot concrete tunnels referenced]. FS Date: 10/10/2013

WS view: 4 ft. by 8 ft. concrete box with slide gate on levee slope. USED bench mark on top of the box.

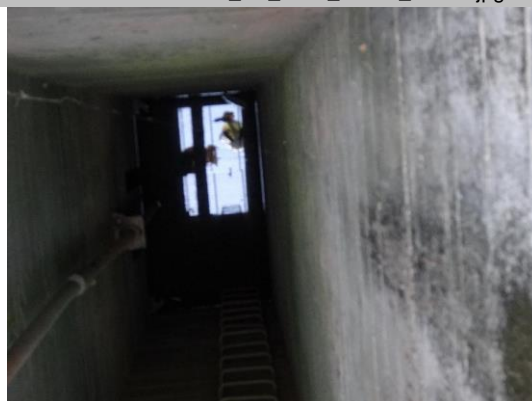
Photo 2 of 3 : UCIP\_FA\_2018\_22663\_38247.jpg

WS view: inside view of concrete box on levee slope. Slide gate in concrete box.

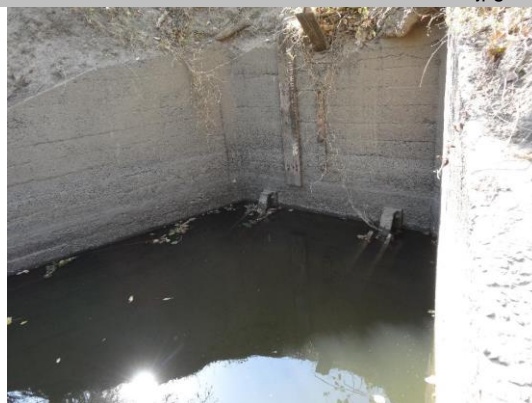
Photo 3 of 3 : UCIP\_FA\_2018\_22663\_38246.jpg

WS view: closer view of U shaped concrete headwall in bypass channel.  
Pipe not visible.

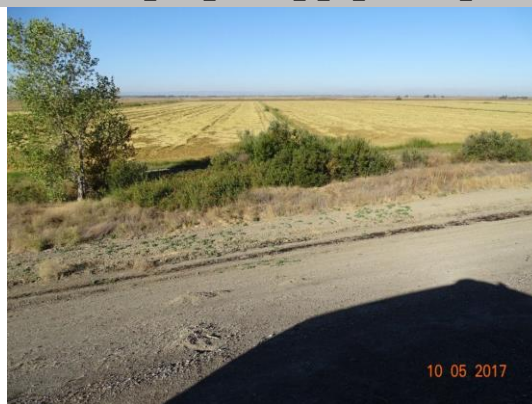
Photo 1 of 1 : FA\_2018\_RD1660\_9\_23\_20180905\_00007.jpg

LM Start	1.43	Rating **	M	Issue No.	23
LM End	1.43	Issue Type +	Ma	Location *	LS
Category	Earthen Levee			GPS Latitude/Longitude	
				Start	End
Item	Animal Control			39.052687 °	39.052687 °
				-121.751720 °	-121.751720 °
DWR ID	DWR_RD1660_02_f_2017_23				
Comment Code					
A3 : No rodents visible, but rodent burrows visible; need to backfill and compact or grout burrows.					
Inspector Comment					
Repair the rodent holes on the landside slope.

View of the rodent holes along the landside slope.

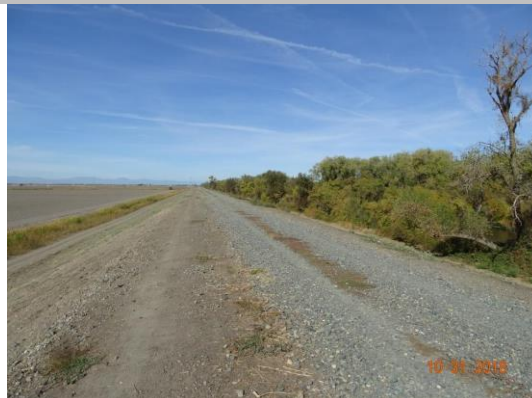
Photo 1 of 1 : FA\_2018\_RD1660\_9\_8\_20181102\_00017.jpg

LM Start	5.73	Rating **	A	Issue No.	8
LM End	5.73	Issue Type +	Ma	Location *	LS
Category	Earthen Levee			GPS Latitude/Longitude	
				Start	End
Item	Vegetation			39.108797 °	39.108797 °
				-121.783333 °	-121.783333 °
DWR ID	DWR_RD1660_02_f_2018_8				
Comment Code					
V1 : Control annual grass and weeds on the levee slopes and easements.					
Inspector Comment					
There was no vegetation on both slopes.

View of no vegetation on both slopes.

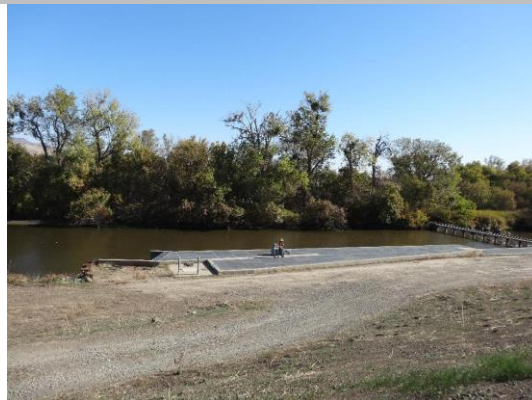
Photo 1 of 3 : UCIP\_FA\_2018\_22708\_38406.jpg

Comment Code					
Inspector Comment					
FS_ID:22708					
DS_ID:22505					
EP_NO: N/A					
Repair Type: No Action Needed					
Crossing Status: Found					
UCIP Comments: - inlet structure 160 ft off the levee center on landside drainage ditch.					
FIELD_STRUCT_DESC: 48-inch steel gravity drainage pipe through the levee, 29 feet below the crown. Slide gate and concrete bulkhead on the riverbank. Staff gage on the waterside (WS) berm. (Retention of a 48-inch corrugated metal pipe (CMP) through the levee, 29 feet below the crown, a slide gate, and a concrete bulkhead authorized under Automatic Board Order (ABO) No. 10021, 1974 - Butte Slough Irrigation Company, care of Tarke Warehouse). [Additional Reference(s): DWR Levee Log, 2005. USACE Sacramento O&M Manual 133, August 1955, (Station 433+43), 48-inch CMP referenced].					
FS Date: 10/15/2013

WS view: overview of concrete box on channel bank. It looks like a fish ladder. Pipe discharges into this box.

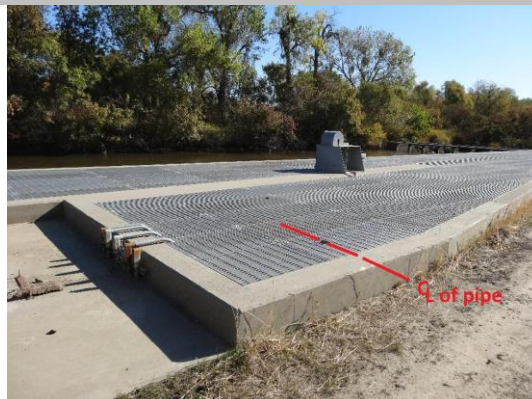
Photo 2 of 3 : UCIP\_FA\_2018\_22708\_38405.jpg

WS view: concrete box on channel bank. Pipe end with slide gate. Pipe discharges into this box.

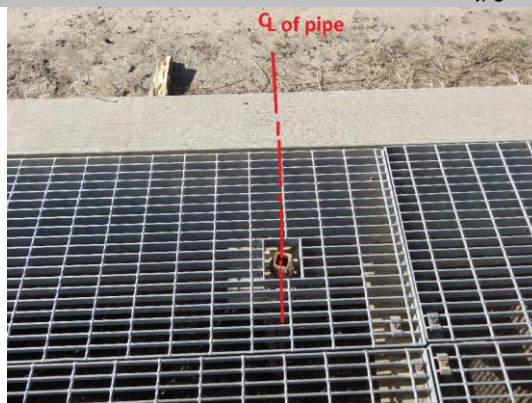
Photo 3 of 3 : UCIP\_FA\_2018\_22708\_38409.jpg

WS view: concrete box on channel bank. Pipe discharges into this box.  
A slide gate inside this box.
